Untangling Canford Bottom

The A31 Canford Bottom roundabout, is a Highways England, signalised ‘hamburger’ style site, towards the south of England, outside Bournemouth. Figure 1 shows the site location. With six signalised approach arms, four of which are local authority roads and two the A31 trunk road, the site can be incredibly busy throughout the week and especially so on Fridays and weekends in holiday season. Being relatively compact for the volumes of traffic it carries, circulatory links are short, with vehicle queuing space as limited as 20m in places. Figure 2 illustrates the general layout.

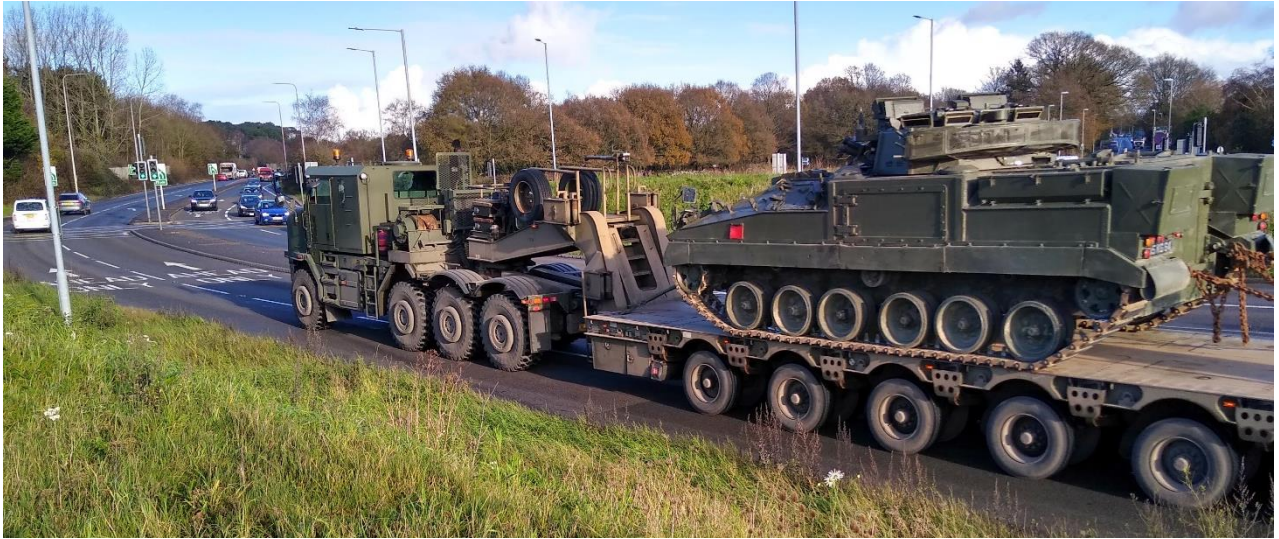
Figure 3 Multiple occurrences of large, slow vehicles on A31

- All exits primarily single lane, although both A31 exits have an 80-100m two to one lane merge.
- High number of HGVs using A31, including multiple occurrences of long, wide, heavy or slow vehicles and also of slow farm vehicles. See Figure 3.

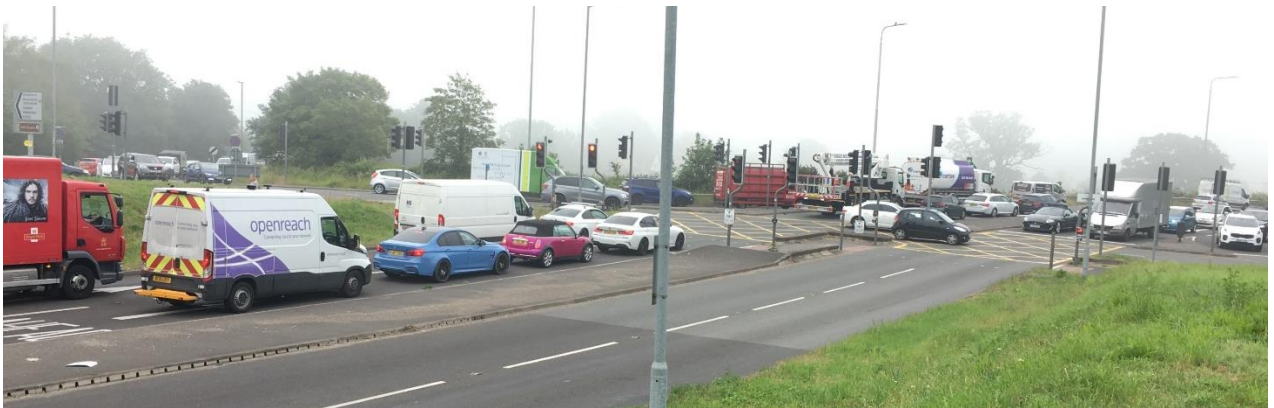
Figure 4 Southbound A31 exit blocking

- The site can suffer significant exit blocking on southbound A31, especially during the evening peak. See Figure 4. It was believed the FT plan was put in place for the evening peak due to MOVA struggling in the exit blocked conditions. Exit blocking could also occur on the northbound A31 exit, although less severely and less frequently.

- Exit blocking was found to be the single biggest cause of congestion. Under exit blocked conditions, queues can quickly build especially on A31 and the two local authority roads on the eastern side of the site. When the A31 exits were clear, queue lengths were generally short.

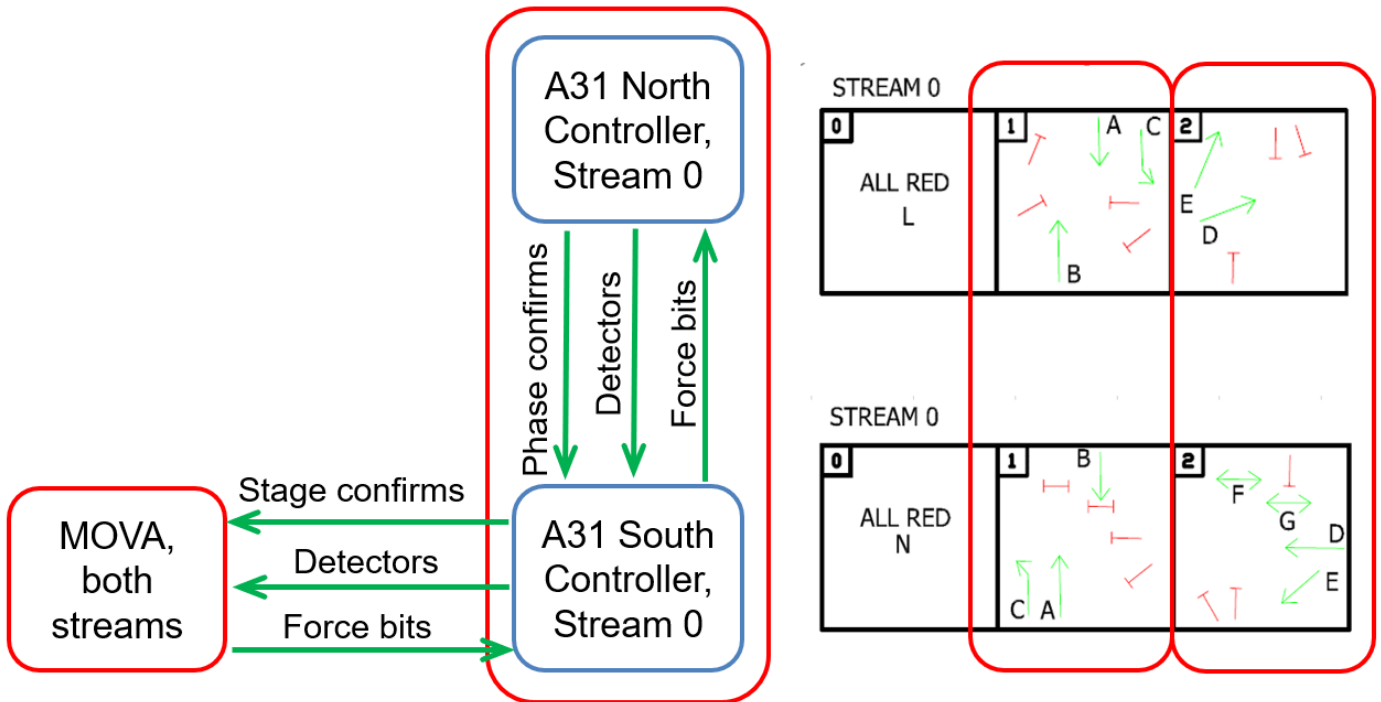
Figure 7 MOVA operation schematic

- Multi core link cables installed between both north and south controllers.
- All detector inputs on the north controller, for the A31 stream, sent as mimic along the link cable to the south controller.

- All detectors on the north and south A31 streams passed to MOVA, as if they were in a single stream.
- Phase confirm bits for the north controller A31 stream sent along link cable to the south controller.

- North controller phase confirms and similar in south controller paired together and passed to MOVA as a single stage confirm reply for each respective stage (A31 in stage 1, both circulatories in stage 2)

- Force bits received from MOVA at the south controller, and as well as controlling the relevant stages there, they are sent as mimic along link cable so that they are similarly received and used at the north controller.

- The above details are described schematically in Figure 7.

In addition, a number of minor facilities were built into the south controller conditioning to control the MOVA CRB reply and TO bits in a similar fashion. Also, a facility was built in to override the stage confirm G bit replies for a few minutes when MOVA first starts control, to use solely the south controller stages: This ensures MOVA can reliably take control if the two controllers were not both running stage 1 together in the alternate control mode.

When configured and tested, the above arrangement utilised a comparatively small amount of special conditioning, a conventional single stream dataset and no traditional MOVA linking facilities at all for the A31. The resulting performance gave 100% reliable coordination for the A31 from the very first cycle and has operated faultlessly since. As intended, the A31 movements through the site, both northbound and southbound start and end green times together, greatly reducing stop/start/stop behaviours, reducing congestion, driver frustration and red light running. Validation for this 'single stream' was carried out conventionally and straight forwardly over approximately one week, including all morning, evening, weekend and holiday peak periods. MOVA was able to balance and control traffic (including pedestrian) movements on all A31 and circulatory phases very well.

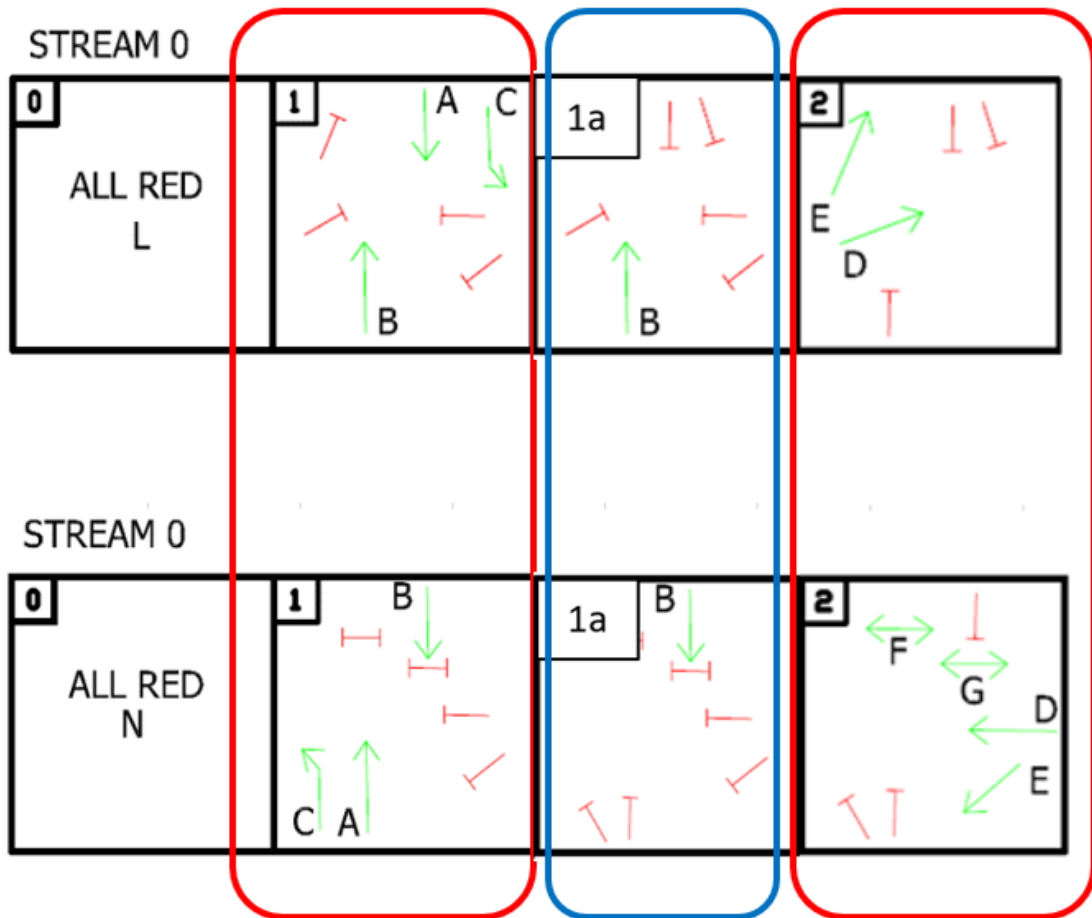
Figure 8 Intermediate internal reservoir clearance stages

A phase delay would otherwise have been used, to hold both phase B (internal reservoirs) at green following the end of stage 1 (A31), as the controller moves to stage 2 (circulatory). To replicate such a phase delay, new intermediate stages were introduced, between stages 1 and 2, which had the internal reservoirs phase at green within them. Figure 8 illustrates this, with the intermediate stage illustrated as stage ‘1a’.

At the end of stage 1, using the controller standard Alternate Stage Moves functionality, all movements are taken via stage 1a. The length of the interstage 1 - 1a is then controlled via the Extend All-Red facility and uses the existing vehicle detectors on the internal reservoirs to vary that interstage. As the internal reservoir phases B remain at green during the interstage, we then see a variable clearance time, running independently on each controller, which ensures vehicles can safely clear the reservoir, but then the circulatory phases can start just as soon as possible, giving capacity gains. Both stages 1a are ‘hidden’ from MOVA and do not have control (F) or confirm (G) bits associated with them. This ensures that MOVA ‘sees’ a standard interstage period between stages 1 and 2, just as if a phase delay was operating.
